Technical Evaluation of the Gold King Mine Incident

San Juan County, Colorado

U.S. Department of the Interior
Bureau of Reclamation
Technical Service Center
Denver, Colorado

October 2015

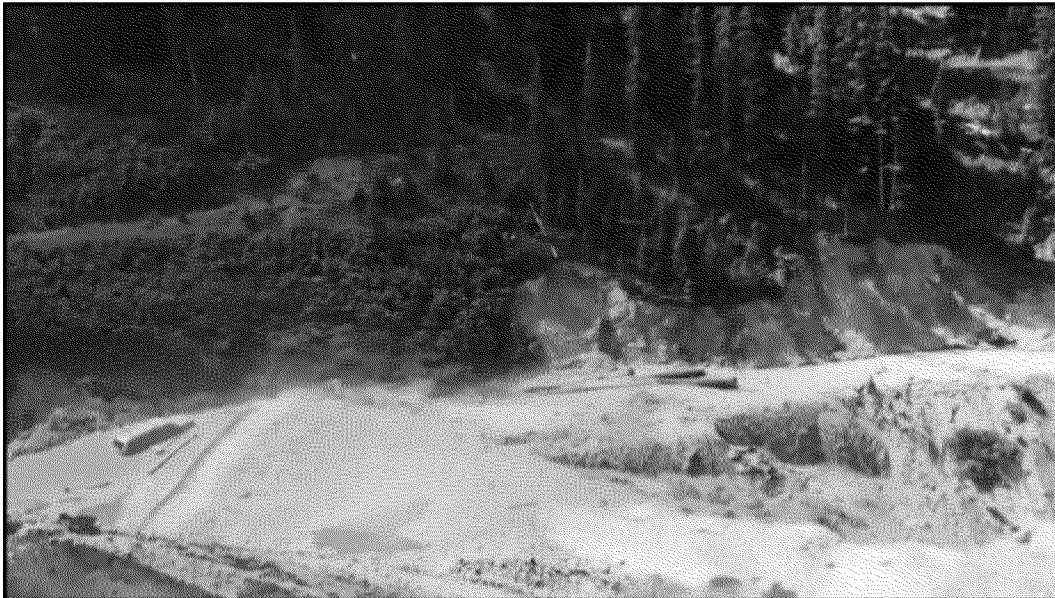
Figure 56.—Photograph showing at left, the inundation of a vehicle parked near the base of the waste-rock dump, and on the right water overwhelming the access road and cascading down into the North Fork of Cement Creek (still frame extracted from a video taken on August 5, 2015, at approximately 10:57 a.m.).
